# **An Experiment in Preventing Zebra Mussel Settlement Using Electro-Expulsive Separation Technology**

Nathan D. Mulherin and Andrew C. Miller

December 2003

ERDC/CRREL SR-03-2  
December 2003

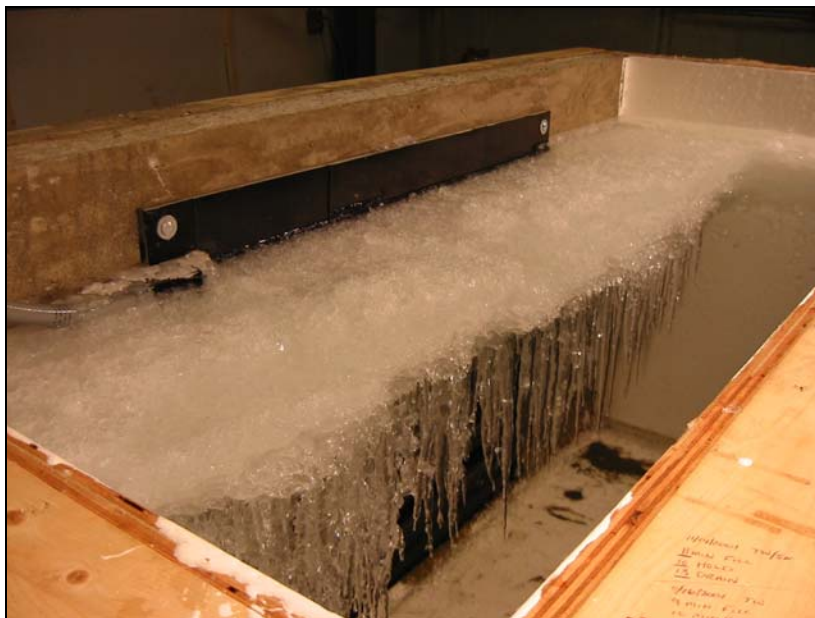
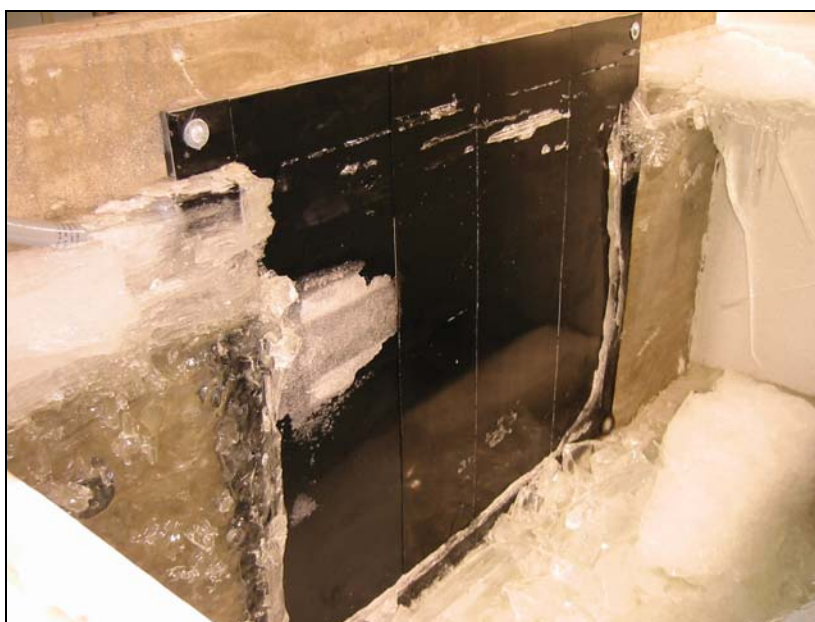
**a. Ice formed on the EES panel (black).**

**b. Panel clear of ice (except for the white patch of frost near left center) after only four firing cycles.**

**Figure 1. Laboratory EES ice removal experiment.**

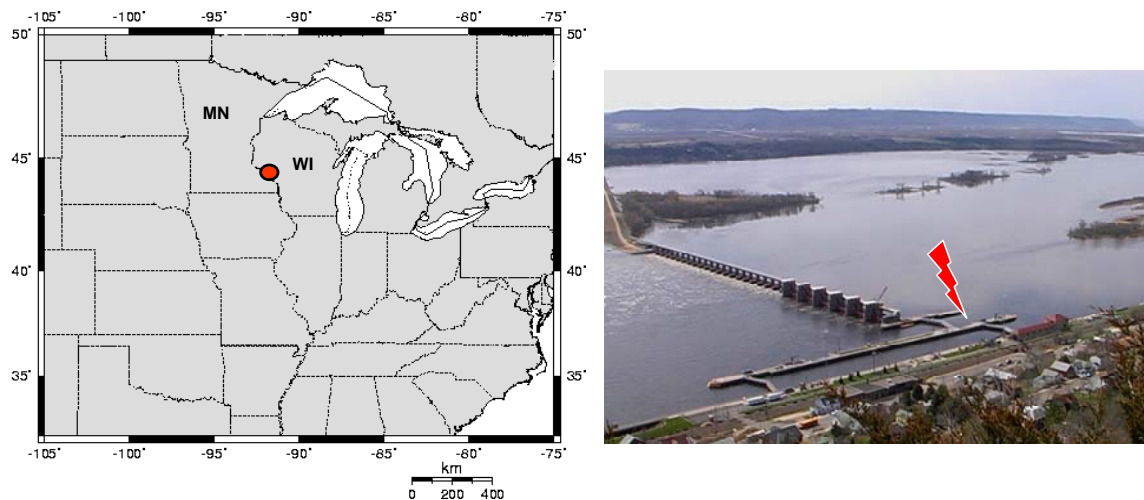
**Figure 2. Site of zebra mussel control field experiment on the Mississippi River between Minnesota and Wisconsin (red circle on map), at U.S. Army Corps of Engineers Lock and Dam No. 4. Red arrow on photo shows field experiment location.**

Our experiment consisted of placing two test panels in the field at a location that experiences seasonal zebra mussel infestation. One was an EESS prototype panel with automatic firing capability (hereinafter referred to as “the live panel”). The second panel, a “control panel,” was similar in size, shape, and material construction, but without EES capability, thereby acting as an experimental control. The panels were monitored and photographed on a regular basis throughout the summer of 2002 to record whether the mussels had colonized them. If the bi-valves attached to the control unit but not to the live panel, then we could assume that the electromechanical action was successful in preventing colonization. The site chosen for our field test was USACE Lock and Dam 4, located on the Mississippi River at Alma, Wisconsin, approximately 128 km (80 statute mi) south-east of Minneapolis, Minnesota (Fig. 2).

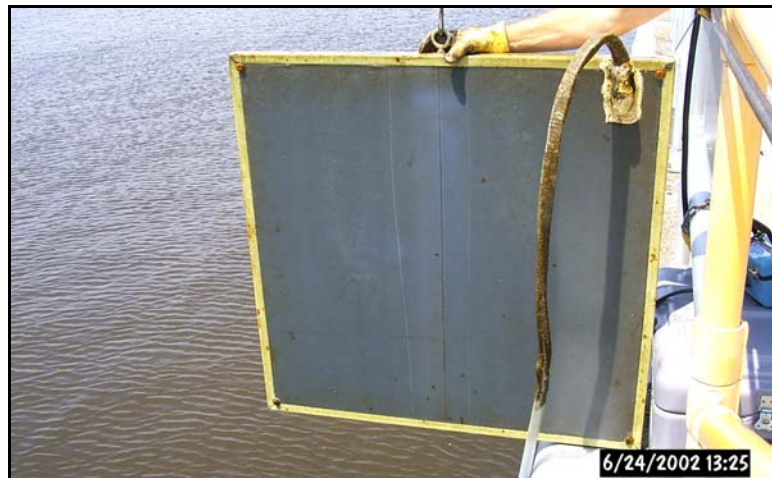
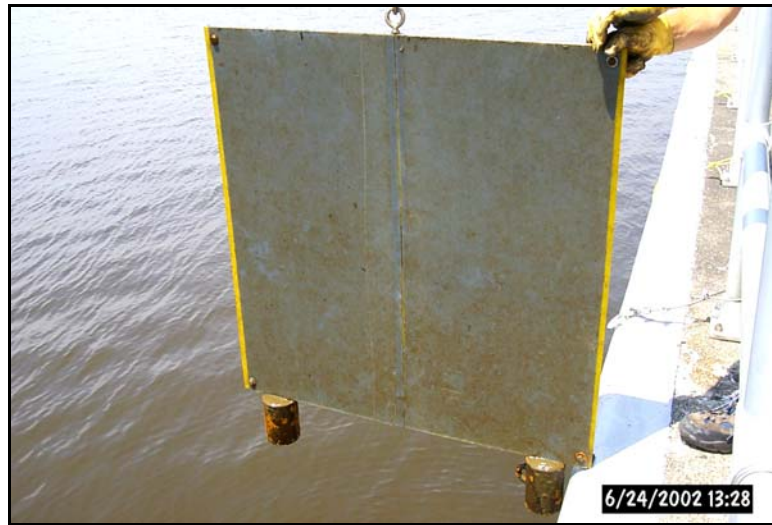
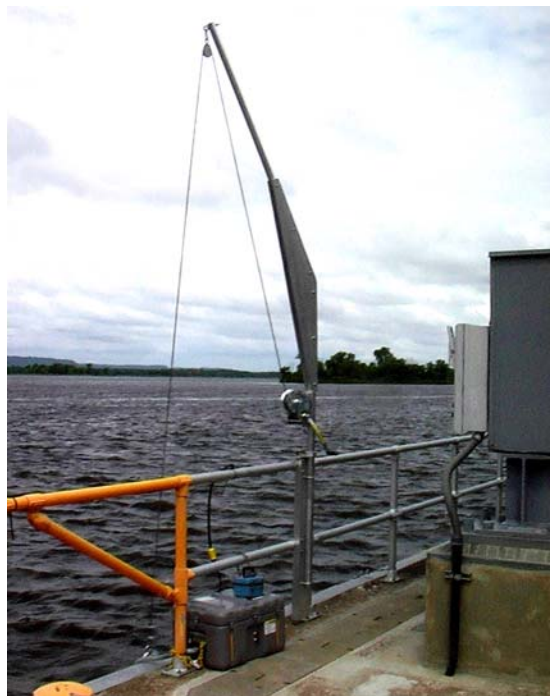
a. EES “live” panel raised out of water for first periodic inspection.

**Figure 3. Panels being checked for mussel infestation.**

**b. EES “control” panel raised out of water for first periodic inspection.**

**c. Hoist used to raise and lower test panels. The large gray box and the small blue box at base of hoist are the EESS’s power supply and control boxes, respectively.**

The live panel consisted of 0.515-in.-wide (13-mm) copper conductors sealed between two sheets of 0.125-in.-thick (3.2-mm) fiberglass, with another sheet of 0.6-in.-thick (1.5-mm) ultra-high-molecular-weight polyethylene (UHMWPE) adhered to the front surface. This composite sandwich was then bolted to a 1-in.-thick (25-mm) aluminum backing plate for stiffness and to ensure that the mechanical energy was directed preferentially toward the front surface. In total,

the live panel measured 3 ft (0.91 m) square and was 1.8 in. (45 mm) thick. It was sealed to prevent the energized ribbons from contacting the surrounding water. For added safety, electrical isolation was guaranteed through the use of a sensor that tripped a circuit-interrupt condition when moisture was detected inside the panel.

The control panel consisted of a single sheet of 0.125-in.-thick (3.2-mm) fiberglass, with another sheet of 0.6-in.-thick (1.5-mm) UHMWPE adhered to its front surface. This assembly also measured 3 ft square. Since it wasn't backed with aluminum, cylindrical steel weights were welded to a bar, which in turn was bolted to the bottom of the control panel to add mass and prevent it from swinging significantly as a result of water currents. Both the control and live panels were suspended vertically in the water alongside the lock wall beginning 14 June 2002. The top of each panel remained at a constant depth of 0.9 m (3 ft) below the water surface. The EES was initially set to fire on a half-hourly schedule. At approximately biweekly intervals, both panels were hoisted out of the water and checked qualitatively for mussel infestation, and photographed (Fig. 3). If inspection determined that mussels were accumulating, then the EESS firing frequency was to be doubled. If there were fewer or the same number of mussels present, then the previous rate would be maintained unless and until subsequent inspection determined otherwise.

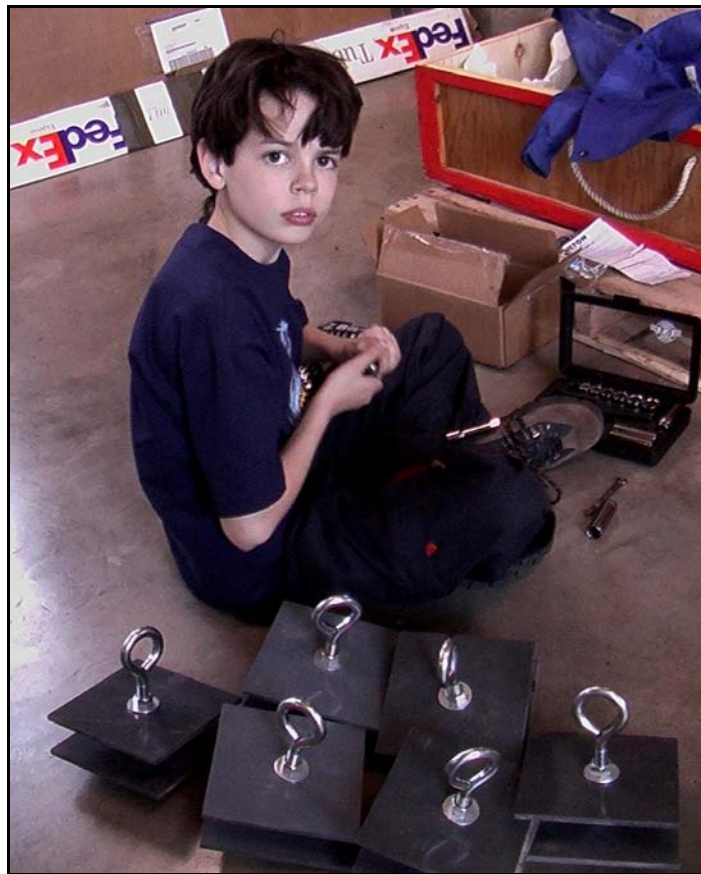
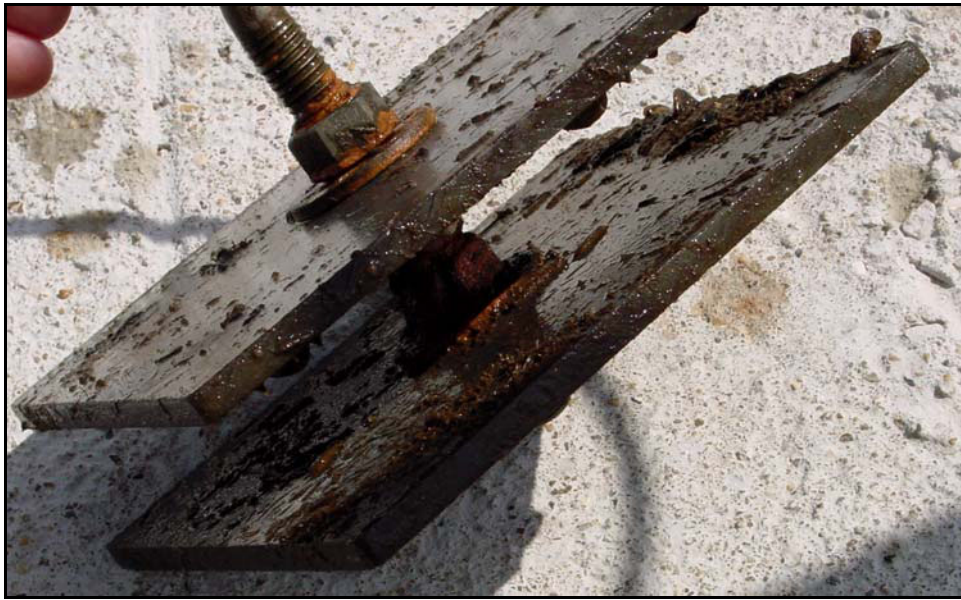
a. Assembling sets of small plates, one each of which was retrieved monthly and returned to the laboratory for sampling.

Figure 4. Plates used for mussel population sampling.

**b. Set of small plates retrieved from the water, showing zebra mussels attached along the right-hand edge.**

To quantitatively document the mussel population at Lock 4, additional strings of PVC sampler plates were suspended in the water adjacent to the panels. It was hoped that the sampler plates would colonize with zebra mussels and provide background information on density and size demography of natural populations in the vicinity of the experiment. The samplers were constructed of two 0.25-in.-thick (7-mm) PVC plates measuring 6 in. (15 cm) on a side with a 0.6-in.- (15-mm-) diameter hole in the center of each. Two plates were positioned horizontally 2.4 in. (7 cm) apart on an eyebolt, and held in place with nuts and washers (Fig. 4). A rope was secured to the eyebolt with the other end attached to a metal railing post at the top of the lock wall. Plate samplers were centered approximately 4.5 ft (1.4 m) beneath the water surface for the summer. The field components were arranged on site as shown in Figure 5.

supports this hypothesis. It shows the mussels preferred attachment between the plates. This hypothesis is supported by research. USACE (2002), citing a study by Claudi and Mackie (1994), states that the juvenile stage of the mussel will settle on internal piping and submerged surfaces where the flow velocity is less than 1.5 m/sec. While the water velocity in the vicinity of our panels was not measured, local turbulence, as stated earlier, required us to weight the control panel to prevent it from swinging in the current. To better promote zebra mussel colonization of the test panels in a future experiment, consideration should be made for reducing the ambient current velocity in the vicinity of the test panels. This might be accomplished, for example, by placing the panels in a more sheltered location, or by enclosing them in baffled stilling boxes that will allow water to freely circulate but at much lower velocity. We anticipate that, with implementation of these changes in our experimental equipment and protocol, and funding for another field season to collect data, our zebra mussel control concept can be proven.

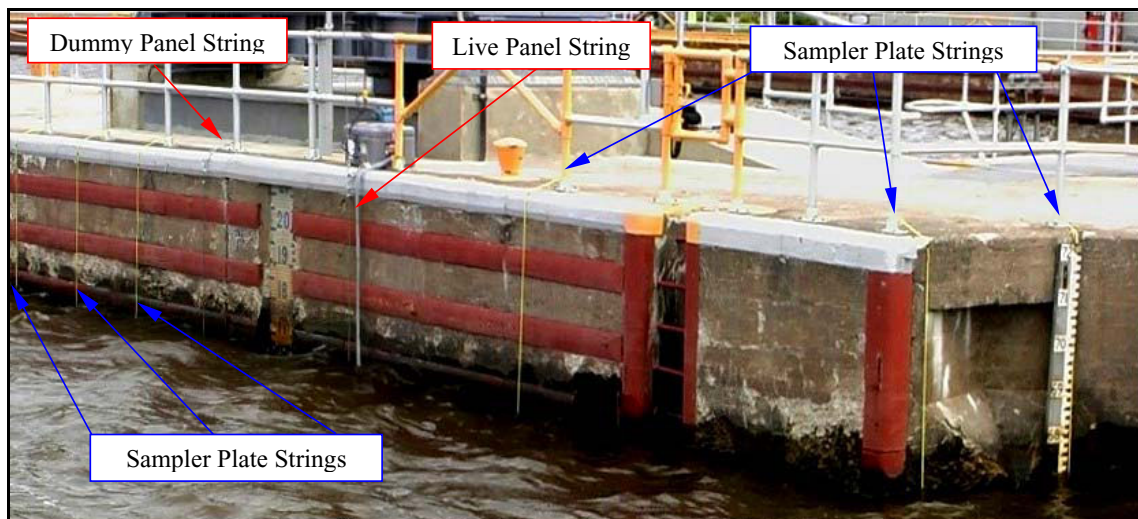
**Figure 5. Experimental arrangement at Lock and Dam 4, showing relative positions of field components.**

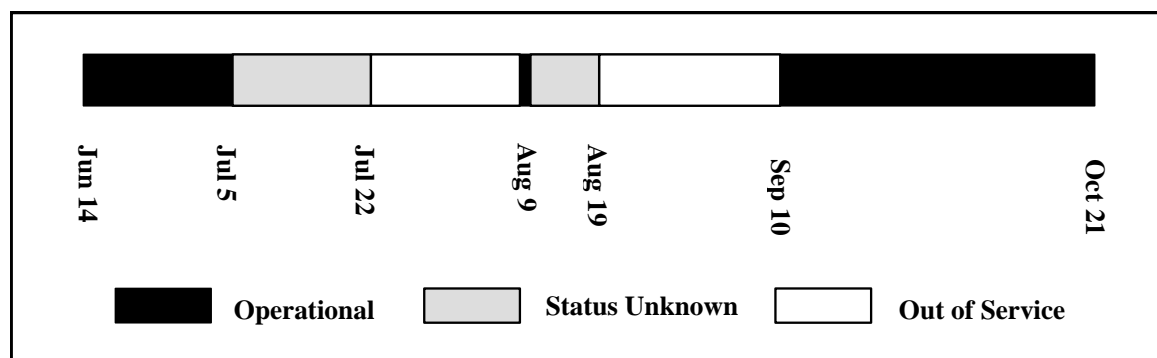
**Figure 6. Timeline of EES system's periods of operation.**

Figure 6 summarizes the system's operational periods during 2002.

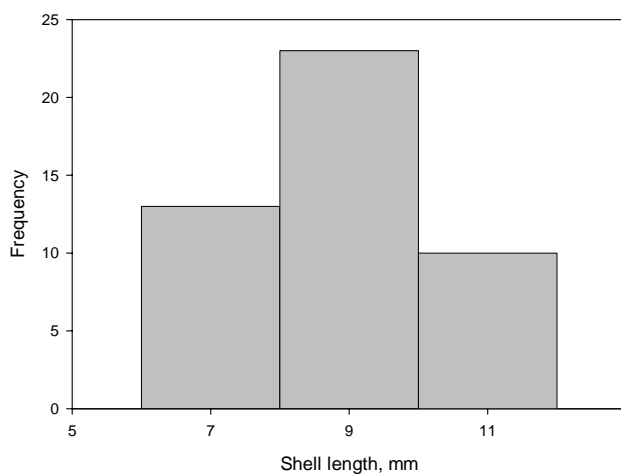
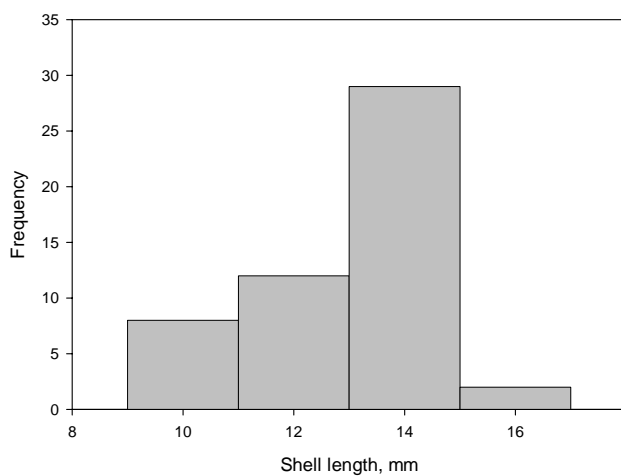
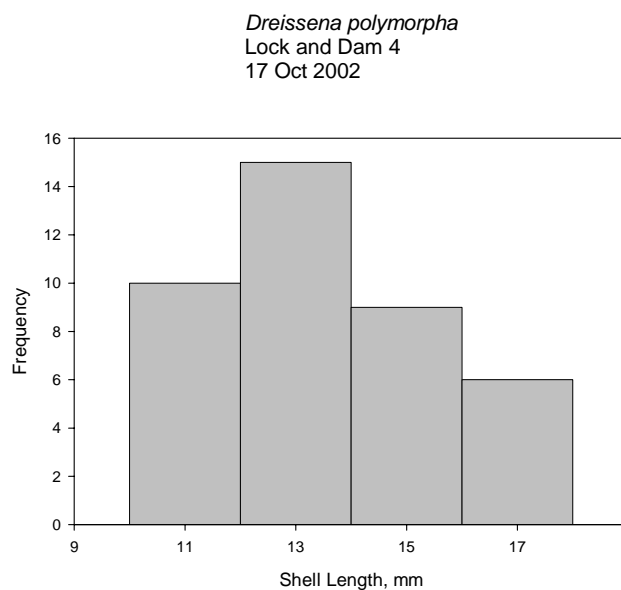
**a. August 2002.**

**b. September 2002.**

**Figure 7. Length frequency histograms for zebra mussels collected from sampler plates at Lock 4.**

**c. October 2002.**

Length frequency histograms for zebra mussels in August, September, and October 2002 appear in Figures 7a–c, respectively. In August, the majority of the mussels were 9 mm long and none were longer than 11 mm. In September 2002 the majority were 14 mm long and the maximum size was 16 mm. Between 5 July and 9 August (35 days), zebra mussels grew an average of 11.72 mm (and possibly more, since they could have settled after 5 July). Between August and September and between September and October, zebra mussels grew an average of 4.33 and 0.55 mm, respectively. See Table 3 for estimated growth rates of the zebra mussels on plate samplers at Lock and Dam 4 during the 2002 season.

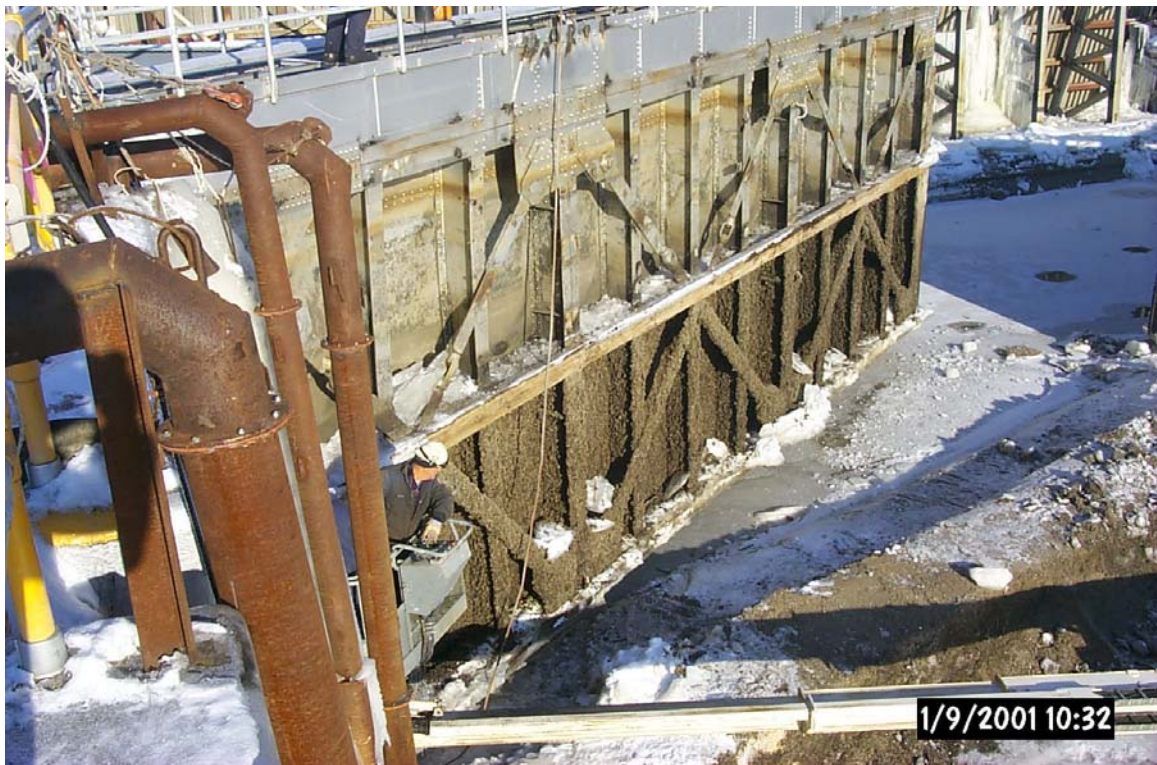
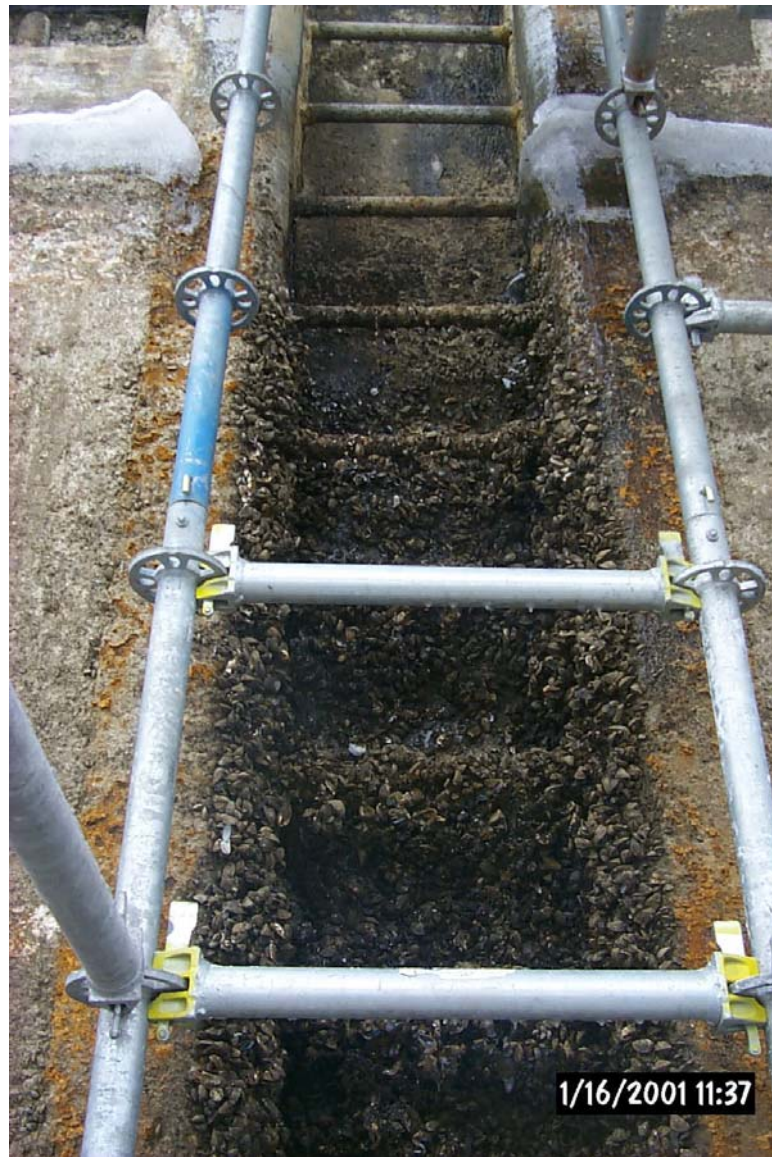
a. Lower half of gate.

**Figure 8. Lock and Dam 4 during January maintenance drawdown in 2001, showing heavy zebra mussel infestation. (Photos provided by L. Meixner.)**

b. Recessed ladder well.

Locations with low-velocity water current appear to be more favorable for zebra mussel settlement. Figure 8 shows an infestation at Lock 4 during 2000. The darker, textured area covering the lower half of the gate (Fig. 8a) is a mass of zebra mussels. Note the heavy infestation in the ladder well (Fig. 8b) where ambient water currents are reduced, but not on the adjacent wall. Figure 4c also
